Thorough Examination Report For Webbing Sling

Company Name:	Aztec Middle East Contracting Llc	Contact Person	Suresh	Contact Number	0569900267
Project Name	Canal Garden Site	Location	Dubai, Warsan, Canal Garden Site	Inspector name	Mohammed Asharaf
Inspection Item	Webbing Sling	Date of Inspection	2020-12-26	Date of Expiry	NA
Certificate Number	BSS-1057	Type of Inspection	Periodic Inspection	Status	Unsafe
Location Details	Canal Garden Substation	Revision	0	Workorder	343

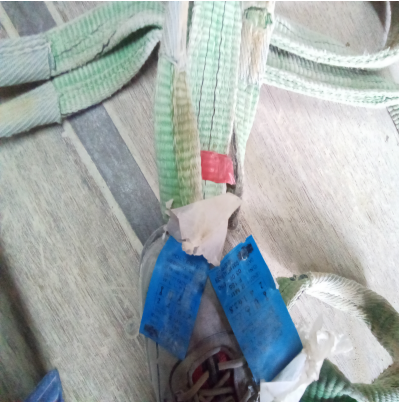
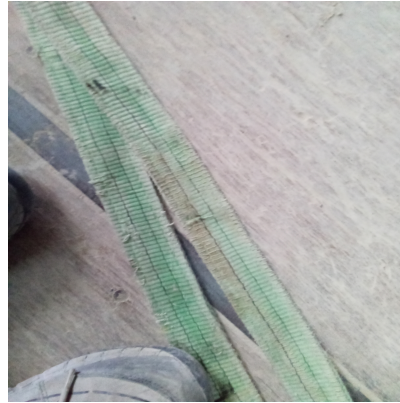
Inspection Images

webbing sling -Description			
Type	FLat	Manufacture	GULF METAL
Material	Polyester	Effective working length	2
Width	2inch	Safety factor	7:1
Working load limit (straight hitch)	Na		
Quantity	02	Serial number(s)	F185,F186
Additional information	Found cuts	Previous inspection date	NA
Accredited Standard	BS EN 1492-1 2000+A1:2008 , BS EN 1492 -2 2000+A1:2008, BS EN 1492 -4 2000+A1:2008	Number of layers	02
Defects			
defect description	Found cut and chafing

Webbing sling - checklist summery	
Legible Markings	Safe
Color coding of label	GREEN
Signs surface chafe	Unsafe
Signs of local Abrasion	Safe
longitudinal and cross cuts in webbing	Safe
Damaged stitching	Unsafe
signs of chemical attack and heat and friction damage	Safe
Weld splatter burns	Safe

Unsafe TO USE
